MODEL 199

P68.30-3328-09

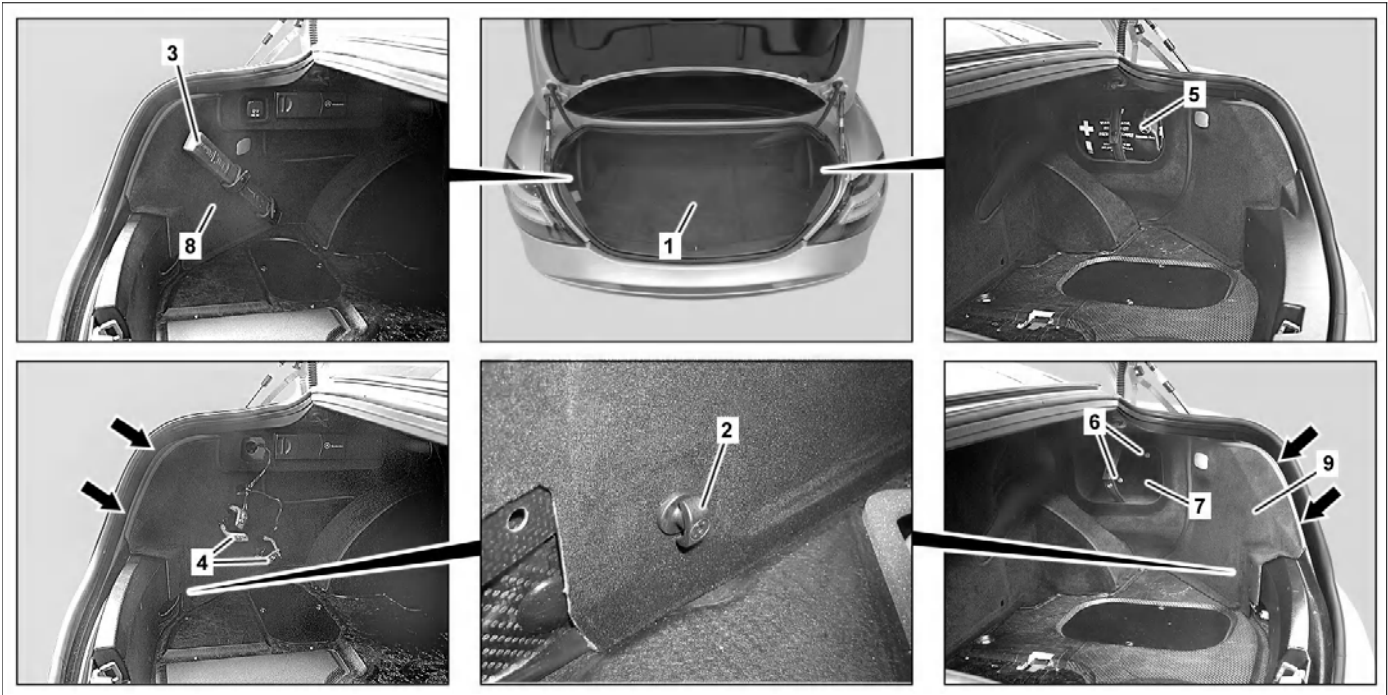
2 Anchoring lug
3 Hazard warning triangle
4 Bracket

5 First aid set
6 Bolts
7 Stowage compartment

8 Side paneling in trunk on left
9 Side paneling in trunk on right

Remove/install		
1	Remove paneling in center of luggage compartment	Model 199.3 Model 199.4	AR68.30-P-4810SLR AR68.30-P-4810SLC
2	Remove trim from rear end center assembly		AR68.30-P-4785SLR
3	Remove trunk lamp		AR82.20-P-0111SLR
4	Remove auxiliary socket

Left-hand side.	AR54.10-P-0020SLR
5	Remove hazard warning triangle (3)

Left-hand side.	
6	Remove bracket (4)

Left-hand side.	
7	Remove first aid set (5)

Right side.	
8	Remove bolts (6)

Right side.	
9	Remove stowage compartment (7)

Right side.	
10	Remove lashing eyes (2)

On model 199.3 two clips are installed.	
12	Unclip side paneling in trunk on left (8) or right (9) at rear (arrows) with assembly wedge.

*110589035900
13	Loosen side paneling in trunk on left (8) or right (9) on Velcro strips and remove.
